CCTV OPERATIONAL REQUIREMENT

PRIVACY IMPACT ASSESSMENT

LYME REGIS TOWN COUNCIL

Bridge Technical Consultants Ltd

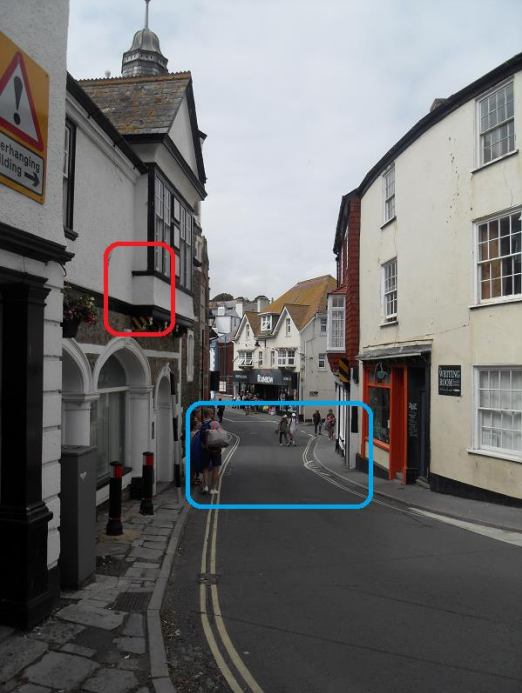
3.4.2.Camera 1

CCTV Operational Requirement Form			
Existing Camera: Yes		Existing Camera DVR Location: LRTC Existing Camera DVR Number: 1	
Area Description: Guildhall Window and Roadway			
Risks & Threats within the area (Known and Determined): The Listed Grade 2* buildings window protrudes into the road. The Guildhall is located immediately after a sharp bend where the road is narrow and only for single vehicles. The window has been hit multiple times.			
Primary View: Guildhall Window and Roadway			
Purpose of View (Norman CCTV Test Target Percentage)			
Purpose: To provide coverage of the Guildhall window area (Red Box in photo) to record any damage that occurs by large vehicles and to capture the vehicles number plate (Blue Box)		Photo of Intended View (See Note 1)

Type of Target: Vehicle			
Speed of Target: Slow moving due to road layout			
Acceptable Area of Coverage: Complete coverage of the road and the Guildhall window area that protrudes into the road

Due to the nature of the requirements number plates will be captured and recorded. However, the duration for storing these images is to be set for Fourteen (14) days as any damage to the building would have been detected in that duration

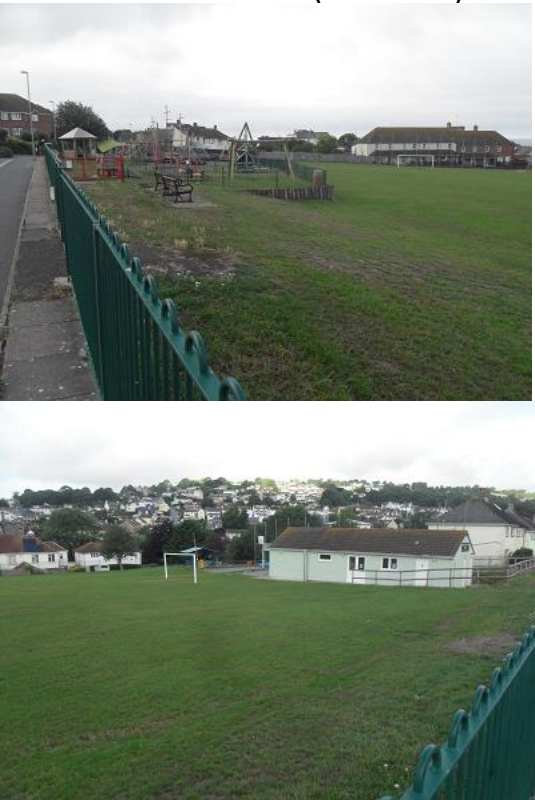
3.4.3.Camera 2

CCTV Operational Requirement Form			
Existing Camera: No		Existing Camera DVR Location: N/A	
Area Description: Anning Road Park			
Risks & Threats within the area (Known and Determined): There have been several incidents of youths gathering in the seated area of the park late at night as well as motorbikes within the park area. Criminal damage has occurred to the public toilets on the end of the Candles on the cobb pavilion			
Primary View: The open park and seating areas			
Purpose of View (Norman CCTV Test Target Percentage)			
Purpose: To DETECT that a person is in the area. To RECOGNISE a known person in the area.		Photos of Intended View (See Note 1)

Type of Target: Person			
Speed of Target: Standing, Seated or Walking			
Acceptable Area of Coverage: Ideally coverage of the grassed area and seating areas but will accept blind spots due to the shape of the area			
Camera Recording Schedule

- The camera is to be a Re-Deployable Pan Tilt Zoom (PTZ) camera that is to be installed to provide Temporary coverage of the park. The camera will record images onboard and these images will be accessible over the mobile phone network.
- It is suggested the cameras is located on lamppost 5A125 which is the location where the photos were taken from

Design features required to address privacy:
The use of privacy masks to provide a black screen over the camera's images should it be pointed at a house that is located around the park

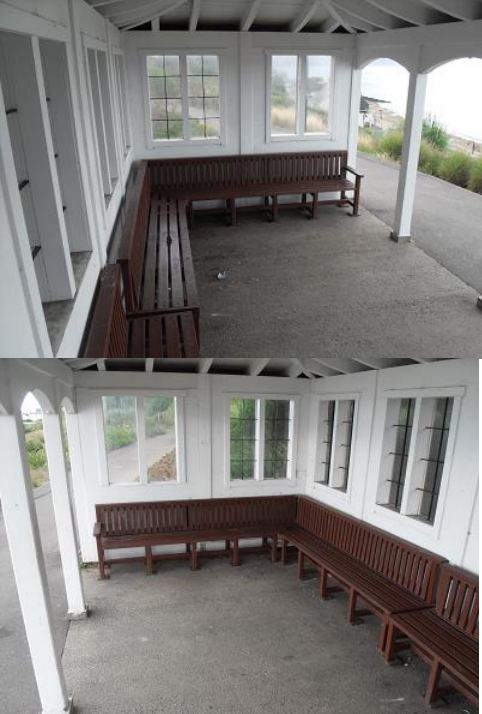
3.4.4. Camera 3

CCTV Operational Requirement Form			
Existing Camera: No		Existing Camera DVR Location: N/A Existing Camera DVR Number: N/A	
Area Description: Langmoor & Lister Gardens - Gazebo			
Risks & Threats within the area (Known and Determined): The Gazebo is used extensively by individuals throughout the day and night who carry out several Anti-Social behaviours.			
Primary View: The inside of the Gazebo			
Purpose of View (Norman CCTV Test Target Percentage)			
Purpose: To IDENTIFY anyone inside the Gazebo		Photo of Intended View (See Note 1)

Type of Target: Person			
Speed of Target: Seated or Standing			
Acceptable Area of Coverage: Full Coverage of the inside of the Gazebo			
Camera Recording Schedule			
FPS: 12	Duration: 24 / 7	Retention: Thirty (30) Days	Retention Policy: To delete all recorded images after 30 days
Camera Requirements			
Audio Required: No	Weather Protection Required: Yes	Vandal Resistant: Yes	Aesthetic Value: No

Lighting Conditions (Day Time): Good		Lighting Conditions (Night Time): Poor Lighting inside the Gazebo	
Any Additional Requirements: The use of a 360 camera could be considered to give full coverage of the inside of the Gazebo

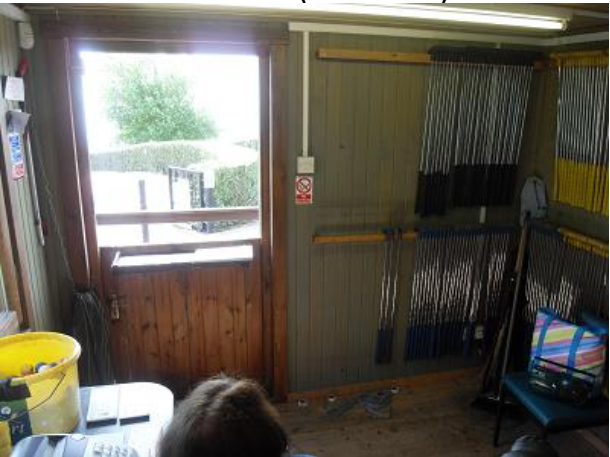
3.4.5.Camera 4

CCTV Operational Requirement Form			
Existing Camera: No		Existing Camera DVR Location: N/A Existing Camera DVR Number: N/A	
Area Description: Langmoor & Lister Gardens – Mini Golf			
Risks & Threats within the area (Known and Determined): The mini golf hut receives cash from members of the public to use the mini golf. The cash is left overnight in the hut. There is a risk from theft at night and during the day from lone working where a single member of LRTC staff is located.			
Primary View: The entrance door hatch and room			
Purpose of View (Norman CCTV Test Target Percentage)			
Purpose: <ul style="list-style-type: none"> To IDENTIFY a person standing at the door hatch. To IDENTIFY a person within the room 		Photo of Intended View (See Note 1)	
Type of Target: Person

Speed of Target: Standing			
Acceptable Area of Coverage: Full coverage of the hatch and room			
Camera Recording Schedule

The camera would be located within the hut and provided recorded images of an employee working. However, the cameras purpose is to provide coverage of the hatch to office the employee protection.

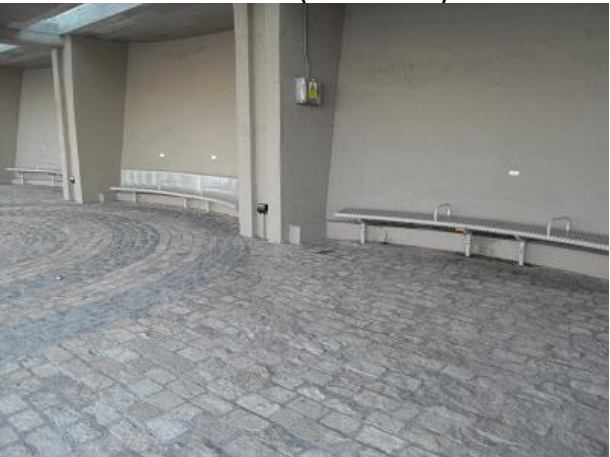
3.4.6. Camera 5

CCTV Operational Requirement Form			
Existing Camera: Yes		Existing Camera DVR Location: Marine Parade Building	
Area Description: Marine Parade – Shelter (Left)			
Risks & Threats within the area (Known and Determined): There have been several report Anti-Social Behaviour issues located within the shelters and on the benches along the Marine Parade			
Primary View: The Left-Hand Shelter			
Purpose of View (Norman CCTV Test Target Percentage)			
Purpose: To RECOGNISE a known person in the shelter		Photo of Intended View (See Note 1)	
Type of Target: Person

Speed of Target: Standing			
Acceptable Area of Coverage: Full Coverage of the area. However if this is difficult with one camera then all benches to be monitored.			
Camera Recording Schedule			
FPS: 12	Duration: 24 / 7	Retention: Thirty (30) Days	Retention Policy: To delete all recorded images after 30 days
Camera Requirements			
Audio Required: No	Weather Protection Required: Yes	Vandal Resistant: Yes	Aesthetic Value: No

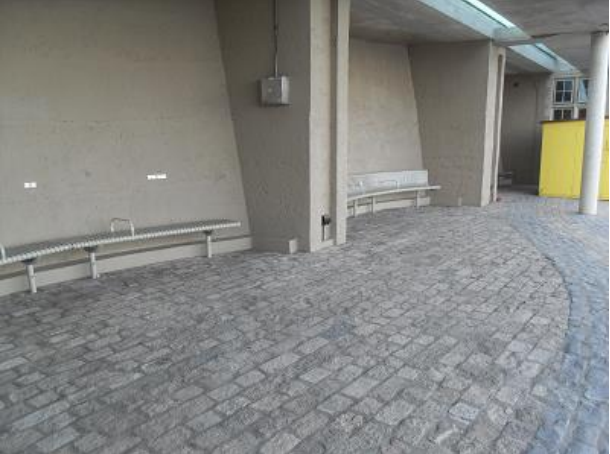
3.4.7.Camera 6

CCTV Operational Requirement Form			
Existing Camera: Yes		Existing Camera DVR Location: Marine Parade Building	
Area Description: Marine Parade – Shelter (Right)			
Risks & Threats within the area (Known and Determined): There have been several report Anti-Social Behaviour issues located within the shelters and on the benches along the Marine Parade			
Primary View: The Right-Hand Shelter			
Purpose of View (Norman CCTV Test Target Percentage)			
Purpose: To RECOGNISE a known person in the shelter		Photo of Intended View (See Note 1)

Type of Target: Person			
Speed of Target: Standing			
Acceptable Area of Coverage: Full Coverage of the area. However if this is difficult with one camera then all benches to be monitored.			
Camera Recording Schedule			
FPS: 12	Duration: 24 / 7	Retention: Thirty (30) Days	Retention Policy: To delete all recorded images after 30 days
Camera Requirements			
Audio Required: No	Weather Protection Required: Yes	Vandal Resistant: Yes	Aesthetic Value: No

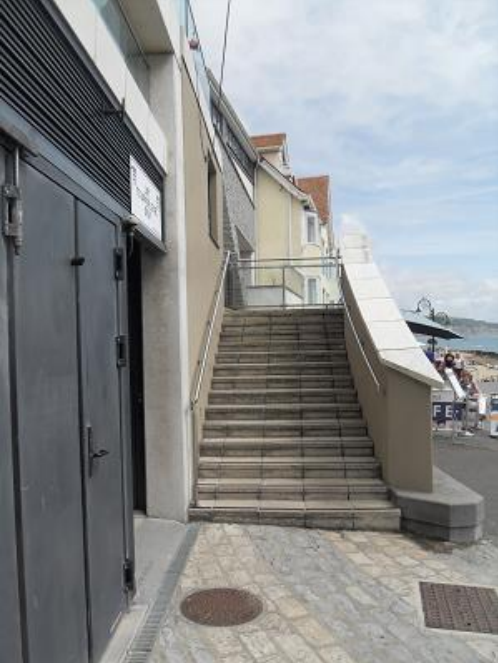
3.4.8.Camera 7

CCTV Operational Requirement Form			
Existing Camera: Yes		Existing Camera DVR Location: Marine Parade Building	
Area Description: Marine Parade – Staircase 1(Bottom)			
Risks & Threats within the area (Known and Determined): There have been several report Anti-Social Behaviour issues located within the shelters and on the benches along the Marine Parade			
Primary View: The Staircase			
Purpose of View (Norman CCTV Test Target Percentage)			
Purpose: To IDENTIFY a person on the staircase		Photo of Intended View (See Note 1)

Type of Target: Person			
Speed of Target: Walking			
Acceptable Area of Coverage: Full coverage of the staircase			
Camera Recording Schedule			
FPS: 12	Duration: 24 / 7	Retention: Thirty (30) Days	Retention Policy: To delete all recorded images after 30 days
Camera Requirements			
Audio Required: No	Weather Protection Required: Yes	Vandal Resistant: Yes	Aesthetic Value: No
Lighting Conditions (Day Time): Good		Lighting Conditions (Night Time): Good lighting level

There are flats located behind the staircase and so the camera needs to be positioned so not to look at the flat balcony

The use of privacy masks to provide a black screen over the camera's images should it be pointed at a flat balcony

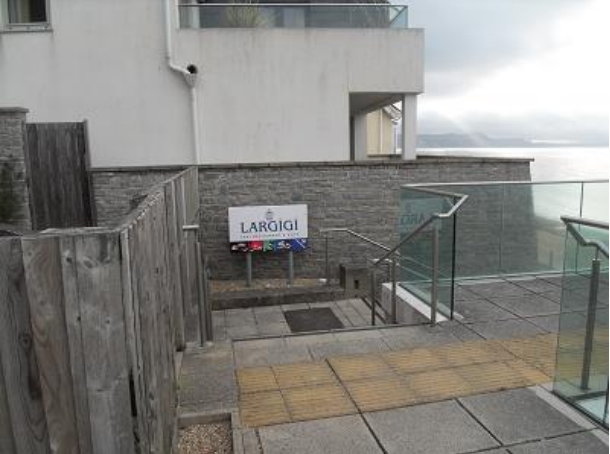
3.4.9.Camera 8

CCTV Operational Requirement Form			
Existing Camera: Yes		Existing Camera DVR Location: Marine Parade Building	
Area Description: Marine Parade – Staircase 1 (Top)			
Risks & Threats within the area (Known and Determined): There have been several report Anti-Social Behaviour issues located within the shelters and on the benches along the Marine Parade			
Primary View: The Staircase			
Purpose of View (Norman CCTV Test Target Percentage)			
Purpose: To IDENTIFY a person on the staircase		Photo of Intended View (See Note 1)

Type of Target: Person			
Speed of Target: Walking			
Acceptable Area of Coverage: Full coverage of the staircase			
Camera Recording Schedule			
FPS: 12	Duration: 24 / 7	Retention: Thirty (30) Days	Retention Policy: To delete all recorded images after 30 days
Camera Requirements			
Audio Required: No	Weather Protection Required: Yes	Vandal Resistant: Yes	Aesthetic Value: No
Lighting Conditions (Day Time): Good		Lighting Conditions (Night Time): Good lighting level

There are flats located behind the staircase and so the camera needs to be positioned so not to look at the flat balcony

The use of privacy masks to provide a black screen over the camera's images should it be pointed at a flat balcony

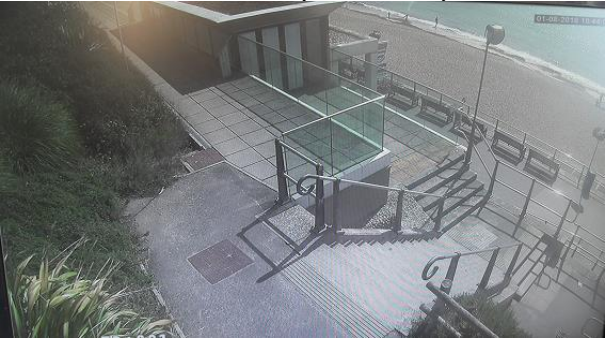
3.4.10. Camera 9

CCTV Operational Requirement Form			
Existing Camera: Yes		Existing Camera DVR Location: Marine Parade Building	
Area Description: Marine Parade – Staircase 2 (Top)			
Risks & Threats within the area (Known and Determined): There have been several report Anti-Social Behaviour issues located within the shelters and on the benches along the Marine Parade			
Primary View: The Staircase and landing			
Purpose of View (Norman CCTV Test Target Percentage)			
Purpose: To IDENTIFY a person on the staircase		Photo of Intended View (See Note 1)

Type of Target: Person			
Speed of Target: Walking			
Acceptable Area of Coverage: Full coverage of the staircase			
Camera Recording Schedule			
FPS: 12	Duration: 24 / 7	Retention: Thirty (30) Days	Retention Policy: To delete all recorded images after 30 days
Camera Requirements			
Audio Required: No	Weather Protection Required: Yes	Vandal Resistant: Yes	Aesthetic Value: No

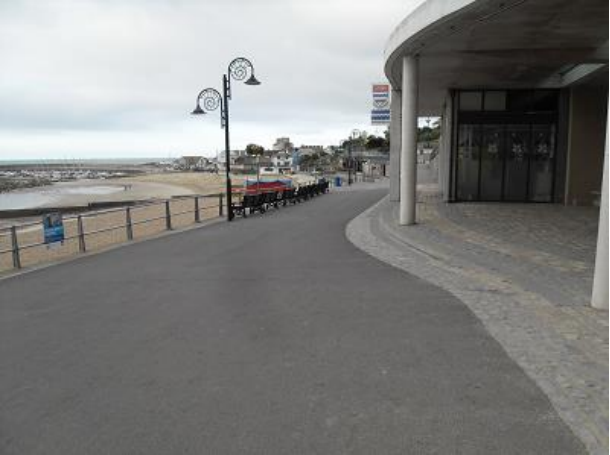
3.4.11. Camera 10

CCTV Operational Requirement Form			
Existing Camera: Yes		Existing Camera DVR Location: Marine Parade Building	
Area Description: Marine Parade – Pinch Point (Left)			
Risks & Threats within the area (Known and Determined): There have been several report Anti-Social Behaviour issues located within the shelters and on the benches along the Marine Parade			
Primary View: The Marine Parade			
Purpose of View (Norman CCTV Test Target Percentage)			
Purpose: To IDENTIFY a person on the Marine Parade		Photo of Intended View (See Note 1)

Type of Target: Person			
Speed of Target: Walking or Running			
Acceptable Area of Coverage: Full coverage across the Marine Parade at a point so not to miss a person passing the building			
Camera Recording Schedule			
FPS: 12	Duration: 24 / 7	Retention: Thirty (30) Days	Retention Policy: To delete all recorded images after 30 days
Camera Requirements			
Audio Required: No	Weather Protection Required: Yes	Vandal Resistant: Yes	Aesthetic Value: No

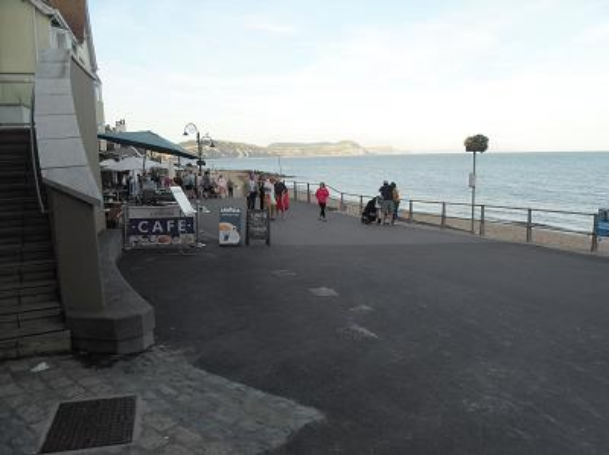
3.4.12. Camera 11

CCTV Operational Requirement Form			
Existing Camera: Yes		Existing Camera DVR Location: Marine Parade Building	
Area Description: Marine Parade – Pinch Point (Right)			
Risks & Threats within the area (Known and Determined): There have been several report Anti-Social Behaviour issues located within the shelters and on the benches along the Marine Parade			
Primary View: The Marine Parade			
Purpose of View (Norman CCTV Test Target Percentage)			
Purpose: To IDENTIFY a person on the Marine Parade		Photo of Intended View (See Note 1)

Type of Target: Person			
Speed of Target: Walking or Running			
Acceptable Area of Coverage: Full coverage across the Marine Parade at a point so not to miss a person passing the building			
Camera Recording Schedule			
FPS: 12	Duration: 24 / 7	Retention: Thirty (30) Days	Retention Policy: To delete all recorded images after 30 days
Camera Requirements			
Audio Required: No	Weather Protection Required: Yes	Vandal Resistant: Yes	Aesthetic Value: No

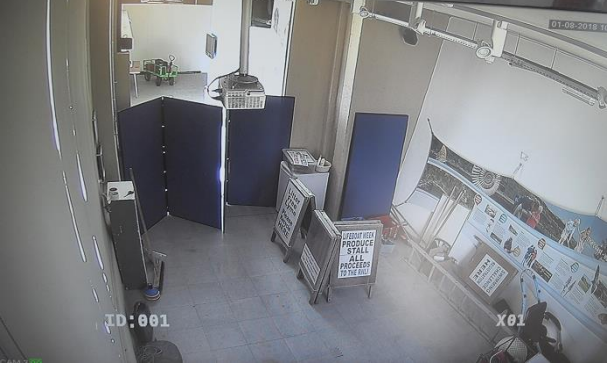
3.4.13. Camera 12

CCTV Operational Requirement Form			
Existing Camera: Yes		Existing Camera DVR Location: Marine Parade Building	
Area Description: Marine Parade Building – Internal (Exhibition Space)			
Risks & Threats within the area (Known and Determined): There have been several report Anti-Social Behaviour issues located within the shelters and on the benches along the Marine Parade			
Primary View: The internal exhibition room			
Purpose of View (Norman CCTV Test Target Percentage)			
Purpose: To IDENTIFY a person in the room		Photo of Intended View (See Note 1)

Type of Target: Person			
Speed of Target: Walking or Standing			
Acceptable Area of Coverage: Ideally Full coverage but blind spots acceptable due to different room layouts during exhibitions			
Camera Recording Schedule			
FPS: 12	Duration: 24 / 7	Retention: Thirty (30) Days	Retention Policy: To delete all recorded images after 30 days
Camera Requirements

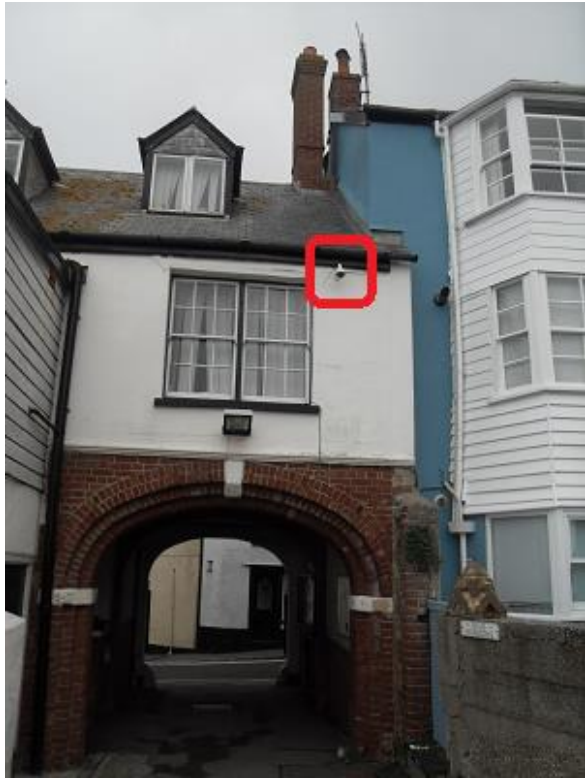
Removal of Existing Camera	
Existing Camera: Yes	Existing Camera DVR Location: LRTC Existing Camera DVR Number: 2
Area Description: Rear of the Lyme Regis Town Council Build, Guildhall Cottage, Church Street	
Primary View: Unknown as not functioning	
CCTV Camera View	
Photo of View

Reason for Removal	
<ul style="list-style-type: none">The camera is not functioning and is providing no useful CCTV coverage of the area
