CCTV RISK ASSESSMENT

LYME REGIS TOWN COUNCIL

| Project: | CCTV Project – Risk Assessment | | |

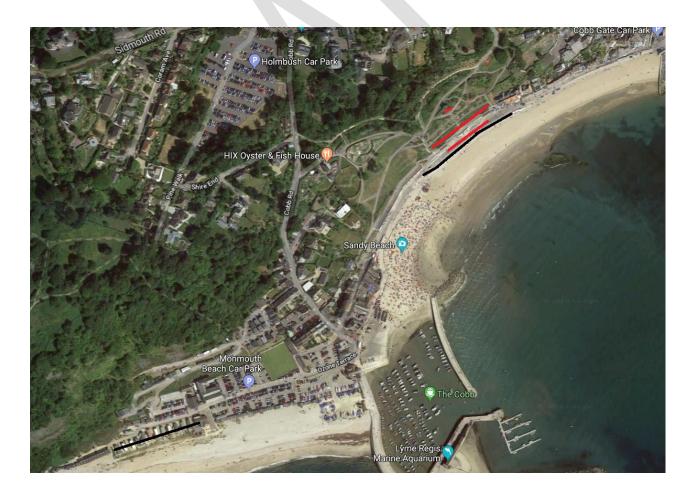
The map below shows where reported crime, as discussed during the site visit, has taken place in the beach front area of the town. It does not highlight individual crimes as per the police figures, these can be seen on the www.police.uk website.

The red lines indicate where it was reported Anti-Social Behaviour is occurring around the beach front.

- Marine Parade Benches
- Langmoor & Lister Gardens Gazebo
- Shelter

The black lines indicate where it was reported Criminal Damage is occurring around the beach front.

- Cart Road Beach Huts
- Monmouth Beach Huts

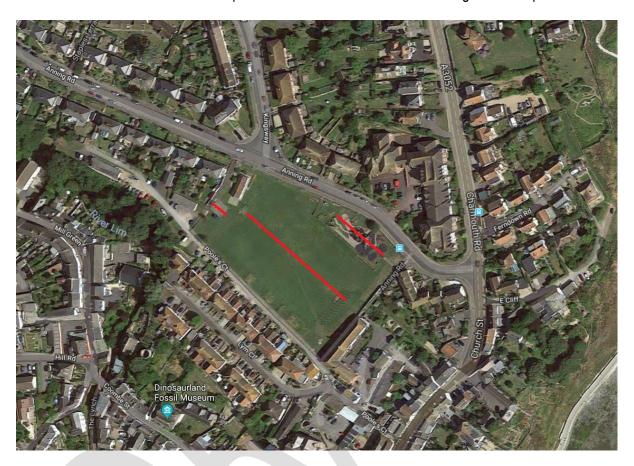
The map below shows where reported crime, as discussed during the site visit, has taken place in the Anning Road park. It does not highlight individual crimes as per the police figures, these can be seen on the www.police.uk website.

The red lines indicate where it was reported Anti-Social Behaviour is occurring within the park.
